### 1730 WINDSOR CHAIR: BEFORE TREATMENT

### Ca. 1730 PAINTED WINDSOR CHAIR: BEFORE TREATMENT

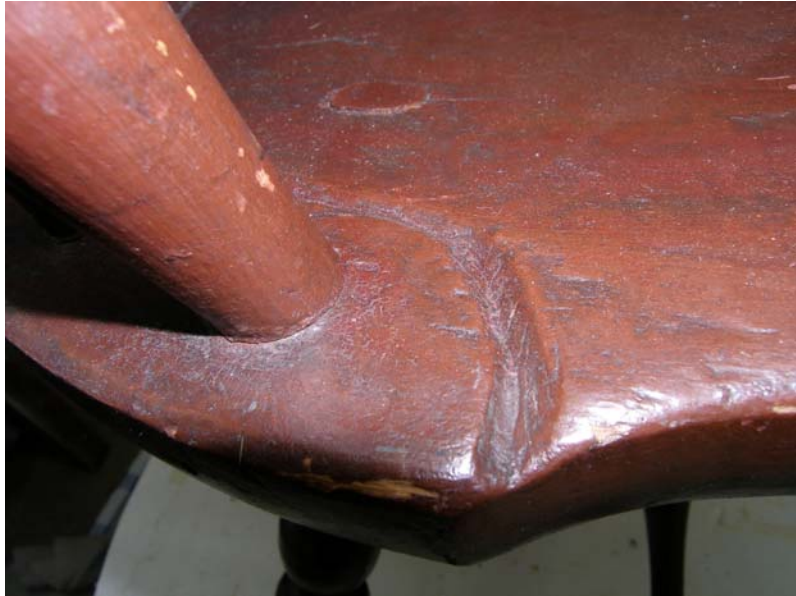
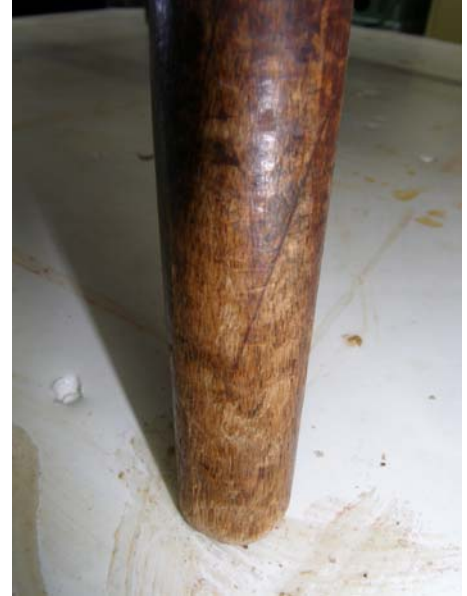
*The chair was extremely dirty, having lived near the kitchen, and had small and large losses in the finish, some of which needed to be infilled and protected from further degeneration.*

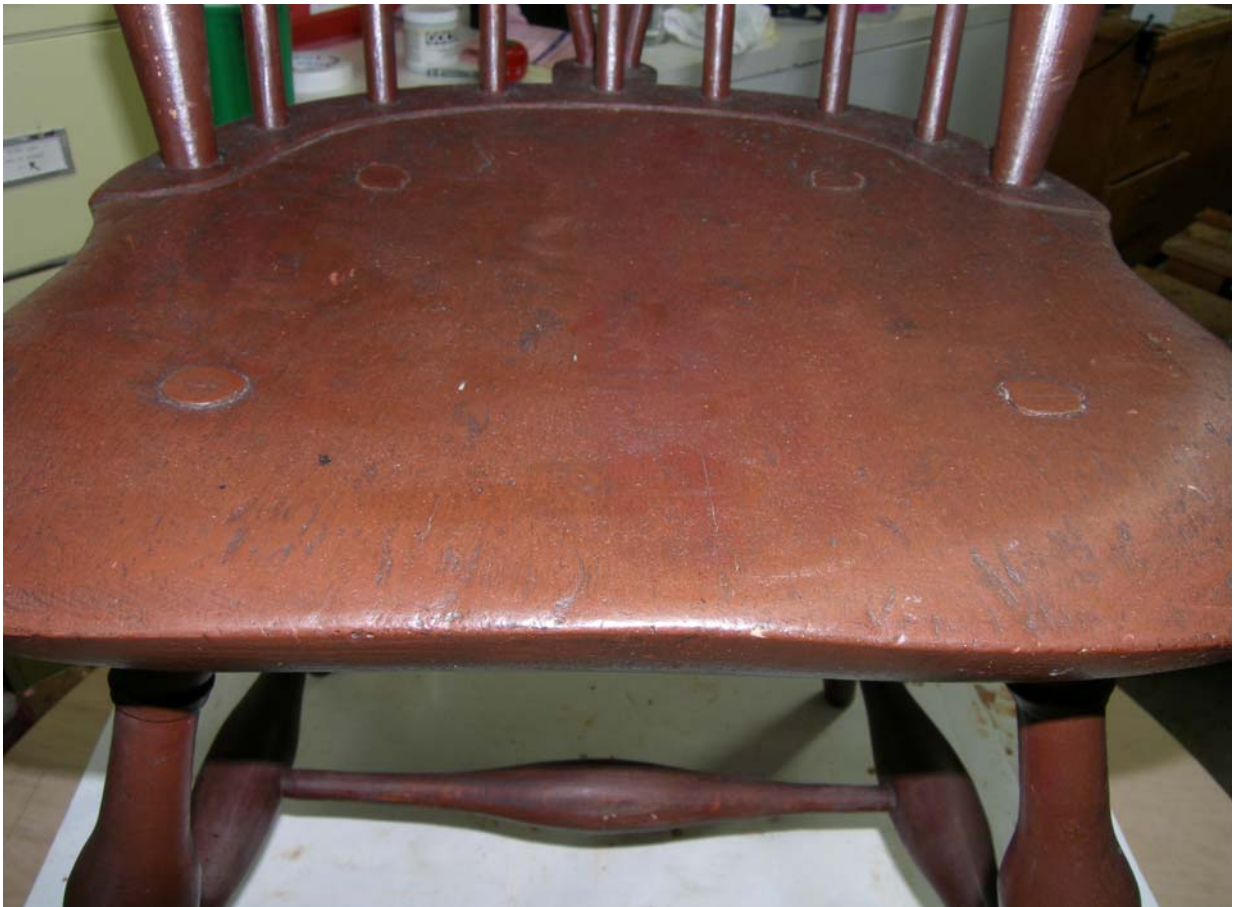
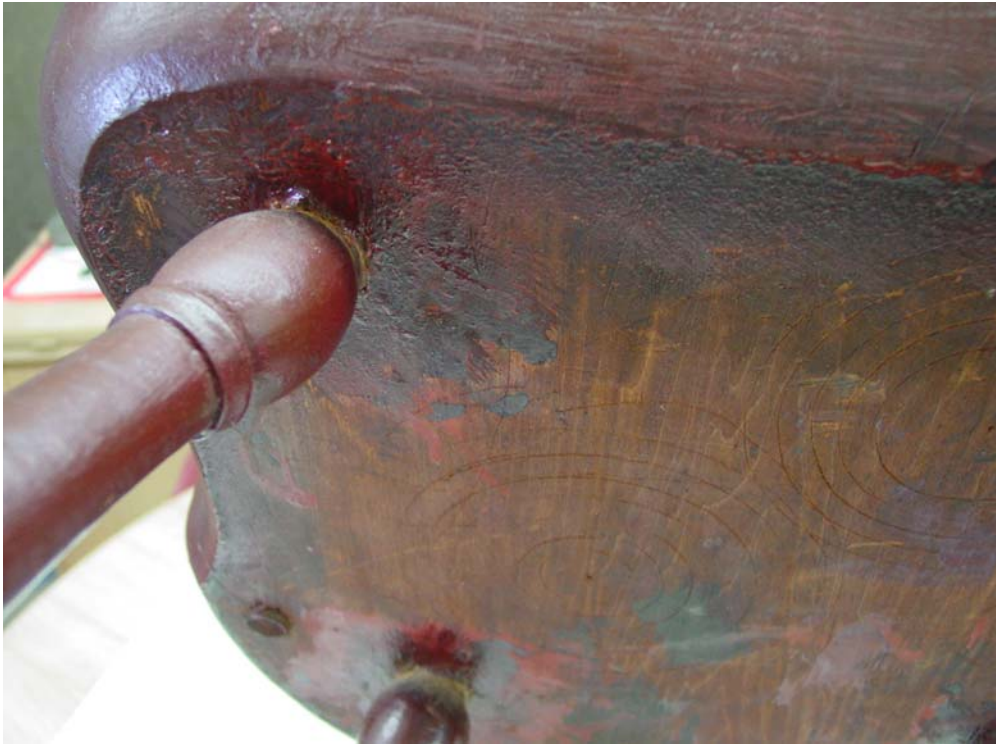
### 1730 WINDSOR CHAIR: BEFORE TREATMENT

*The underside of the chair revealed clues to the paint's age and the number of coats.*

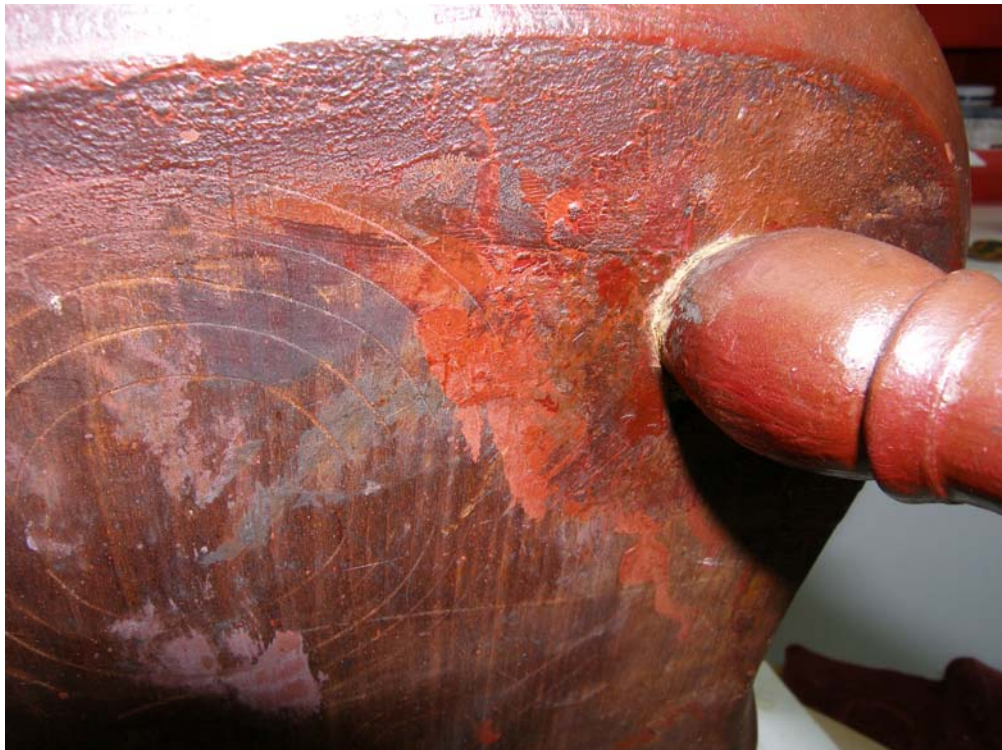
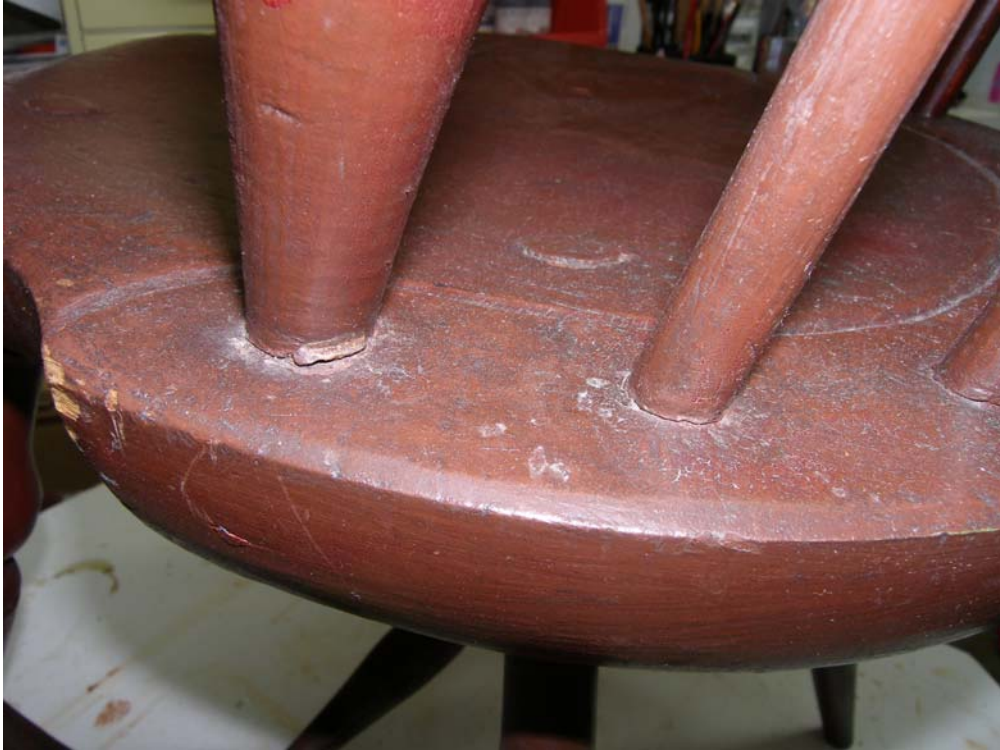
*The chair was in good structural condition, with play but no joints that threatened to fail.*

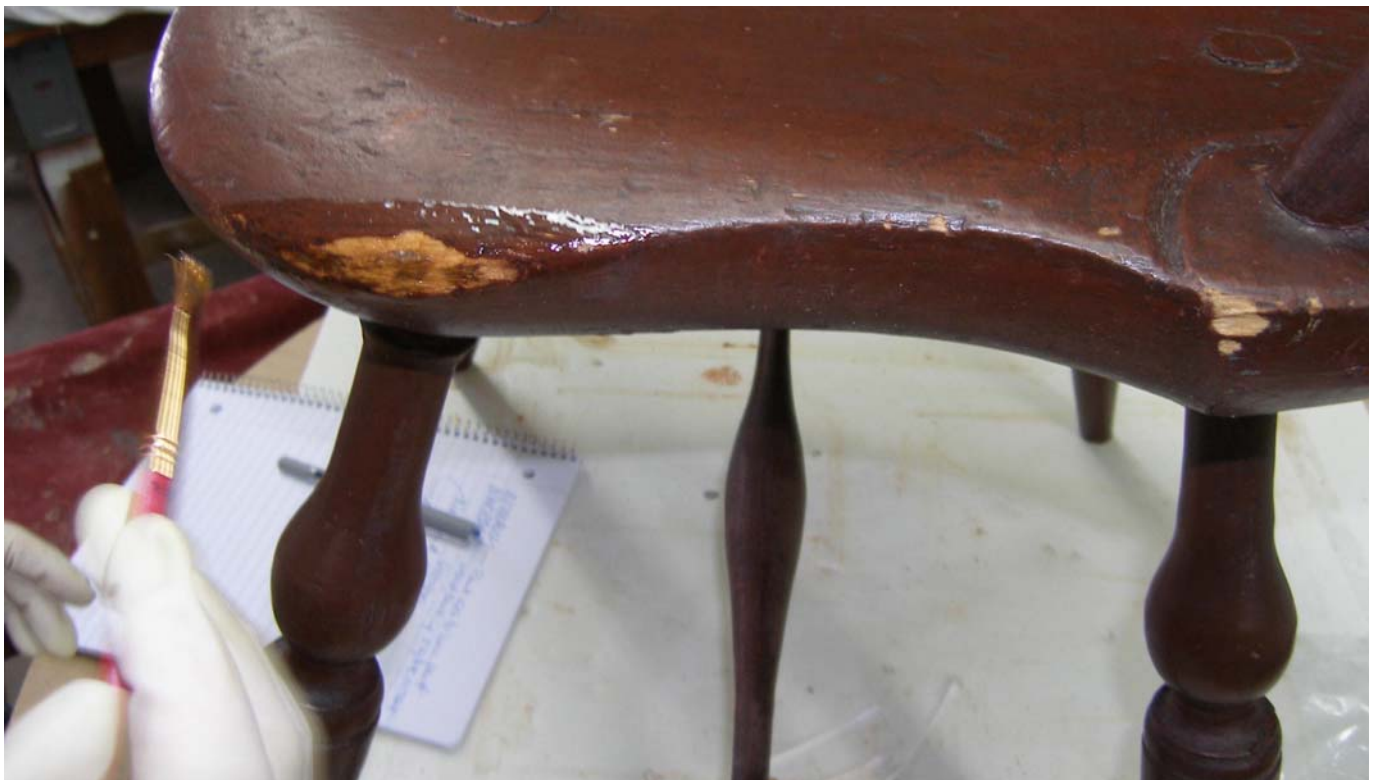
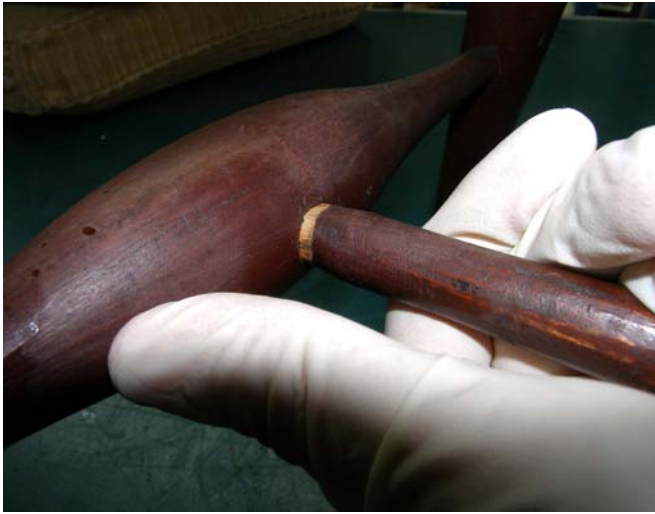
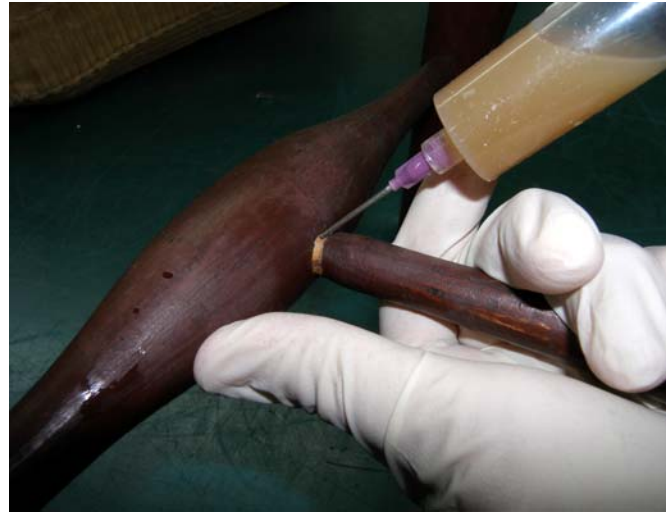
### Ca. 1730 PAINTED WINDSOR CHAIR: REPARATION

*The stretcher was the one compromised area on the chair in danger of failure; rather than disassemble the chair, MPFC chose to repair the loose stretcher with hide glue injected into the joint with a needle.*
