VICTORIAN BEADED ANGEL

## TREATMENT OF A BEADED VICTORIAN ANGEL

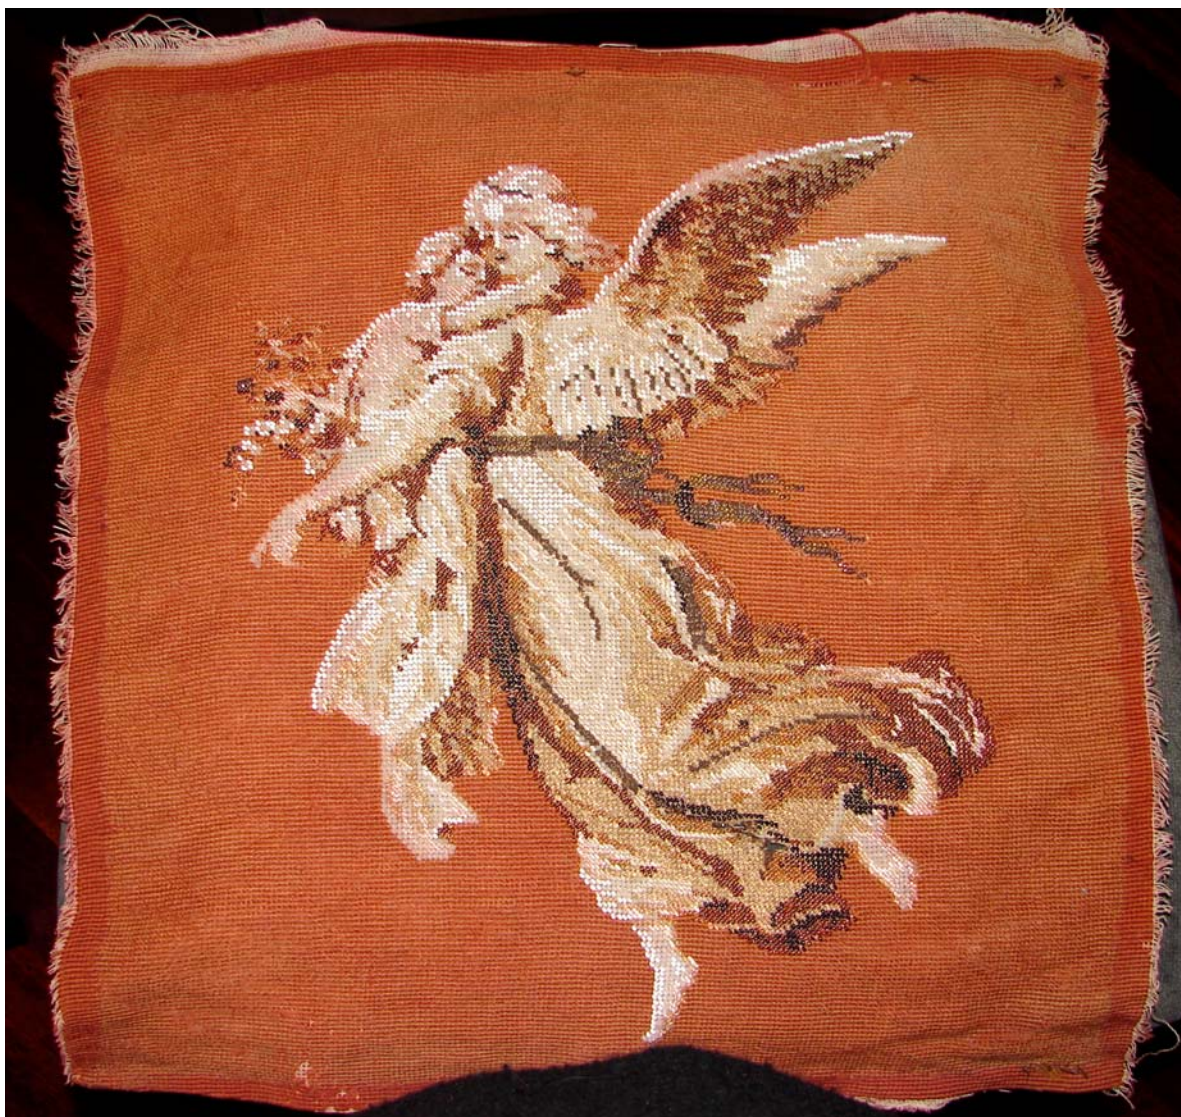
*Family heirloom, a Beaded Victorian Angel, before treatment. Beads missing in her hands, flowers, ribbons (three places), hair, wings, and her skirt (six). Yarn missing in several places, most notably in the lower left.*

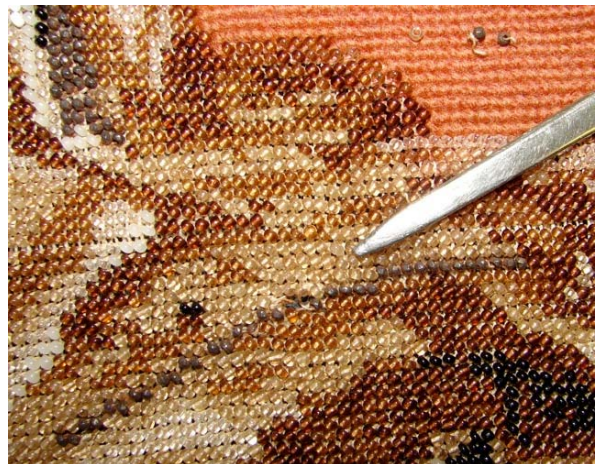
Top right and middle right, a beaded area with a 1 1/2-inch tear shown open and closed.

Bottom right, a second adjacent area to the tear, with 3 tears of 1/4-inch to 1/2-inch.

Top, reverse of the area shown right top and middle.

- I. The assessment in the MPF Conservation (hereafter known as MPFC) studio showed surprising information about the areas of extreme disintegration, an example shown top left, of the reverse side of the beaded item, and right.

- I.I. All areas ripped or disintegrated are areas where metallic beads have encountered either water or chemicals and have made the grid brittle and discolored, and leading to the disintegration.

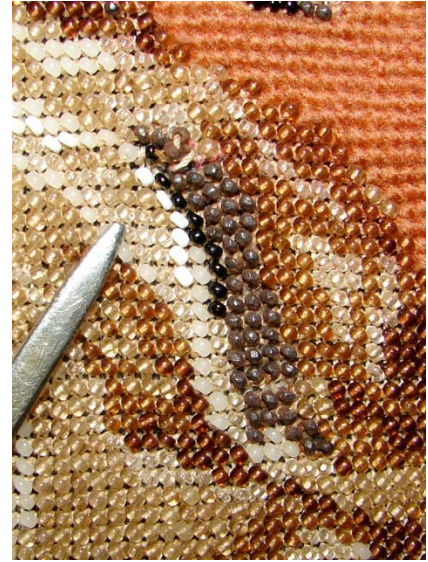
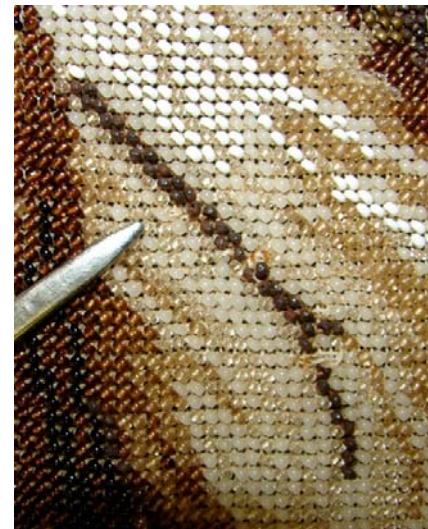
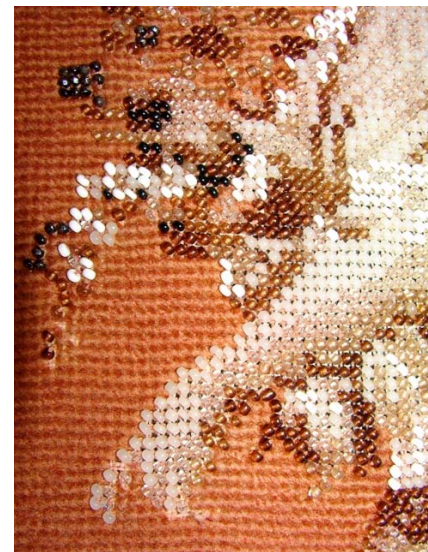
- ¾-inch tear with beads loose for 2-inches on skirt;
- ¼-inch tear with beads loose for 2 ½-inches;
- Two areas of lost beads and loose beads, on the flowers spilling from her hands and her pointed finger.

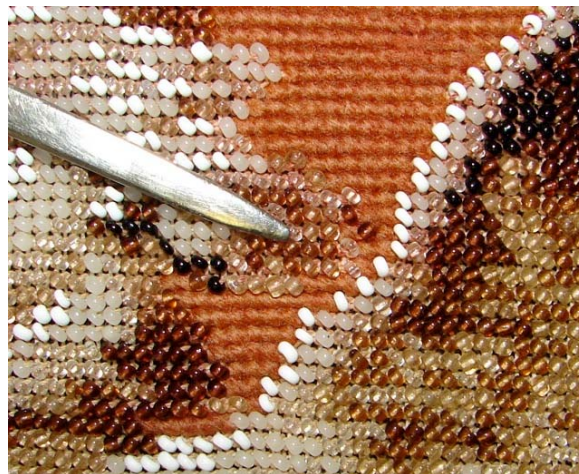
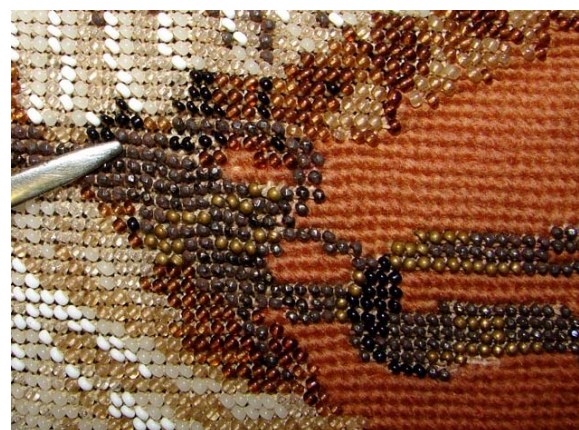
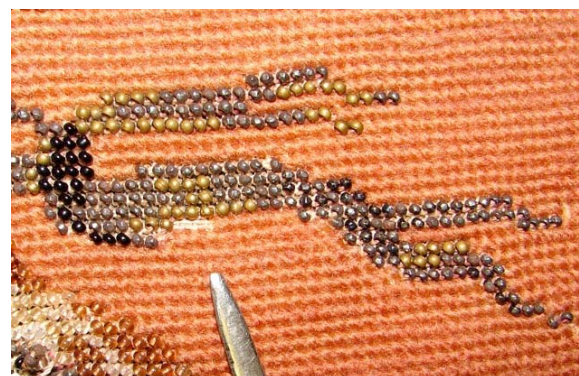
*Loose beads in hair;*

*¼-inch tear with beads loose for 1-inch;*

*Three areas of lost beads and loose beads, on the tips of the ribbons around her waist and on the underside of the ribbon.*
