POLYCHROME ITALIAN CORNER CUPBOARD:  
BEFORE AND AFTER TREATMENT

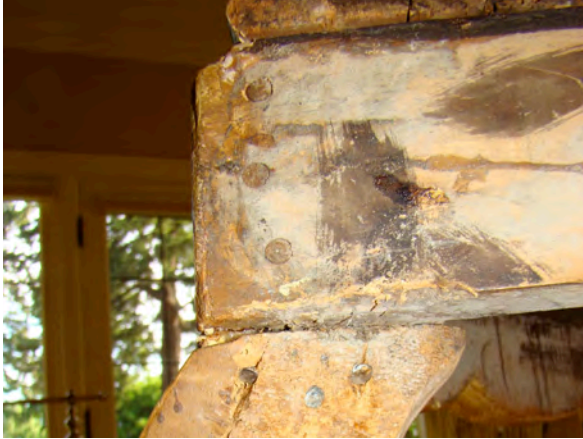
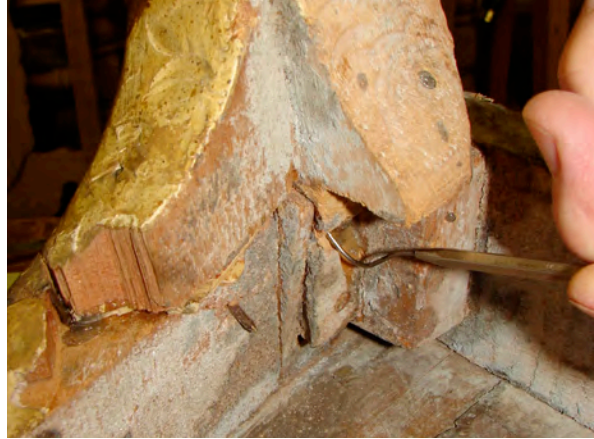
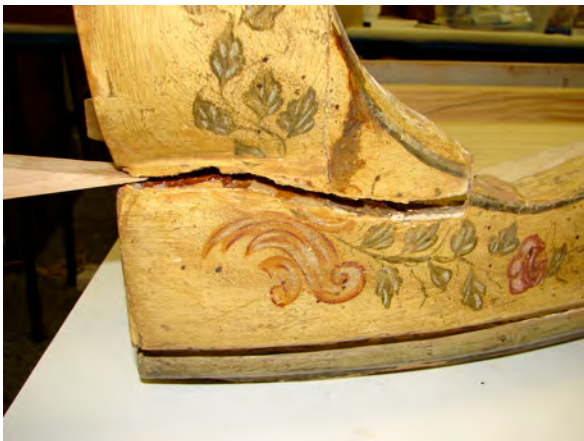
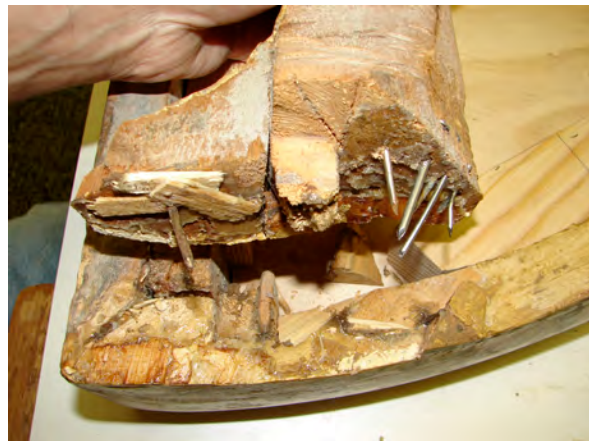
POLYCHROME ITALIAN CORNER CUPBOARD: PROCESS  
(SHIMS WERE USED AS THE PREVIOUS INAPPROPRIATE REPAIR SET THE LEG  
AT AN ANGLE DUE TO LOSSES, WHICH WAS CORRECTED BY SHIMS.)

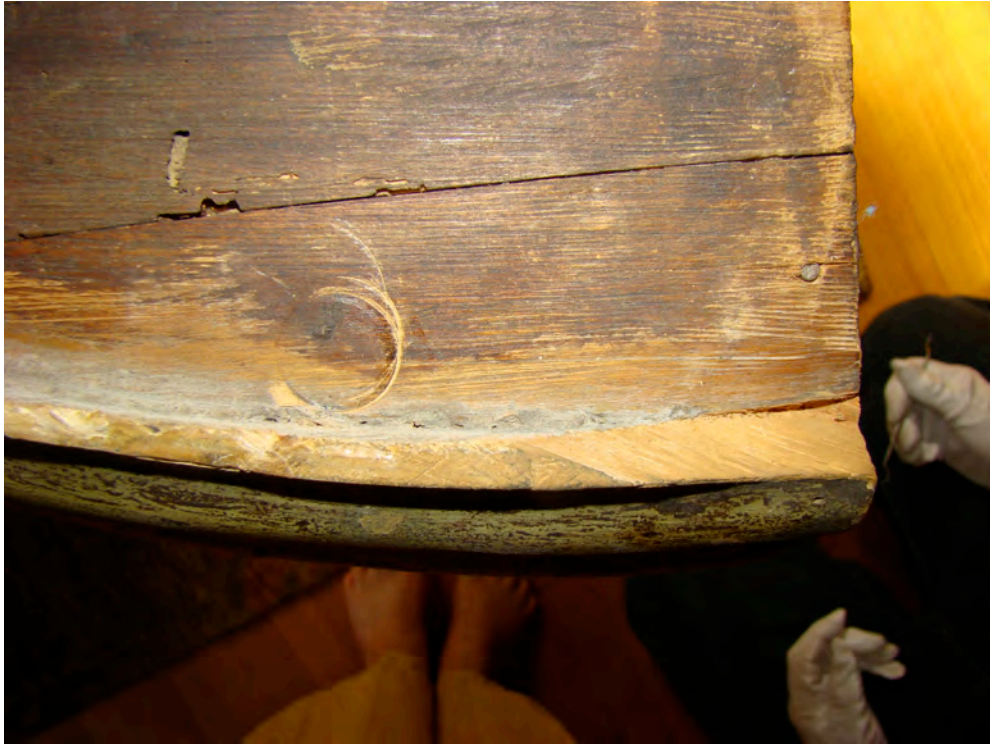
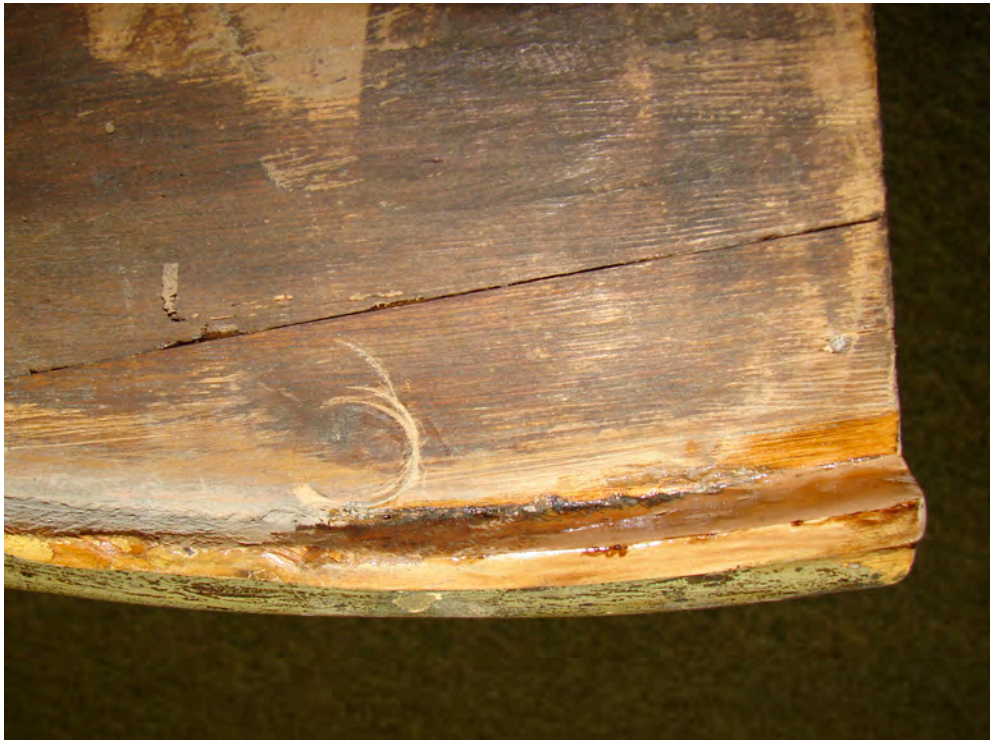
POLYCHROME ITALIAN CORNER CUPBOARD:  
BEFORE AND AFTER TREATMENT  
(NOTE THE C-CLAMP MARK FROM A SLOPPY PREVIOUS REPAIR.)

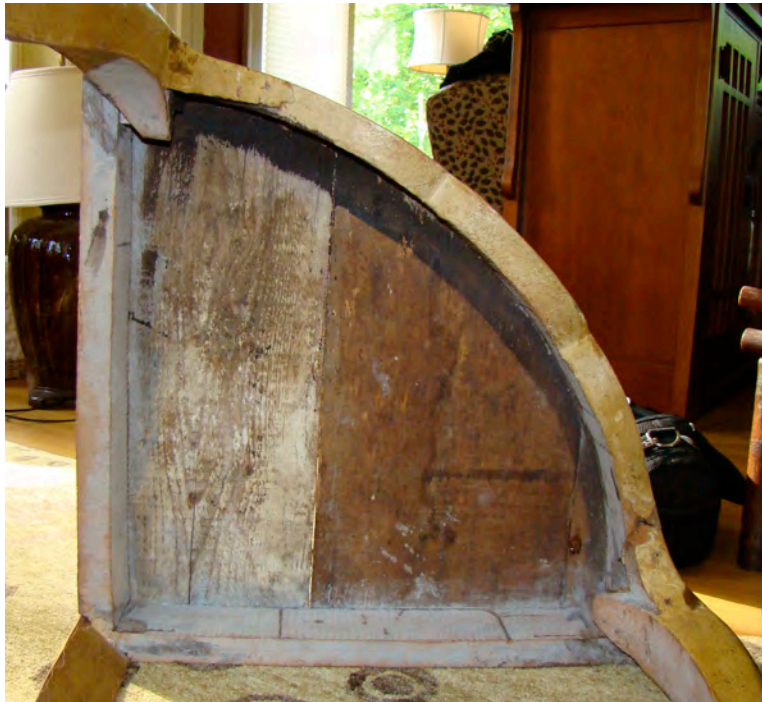
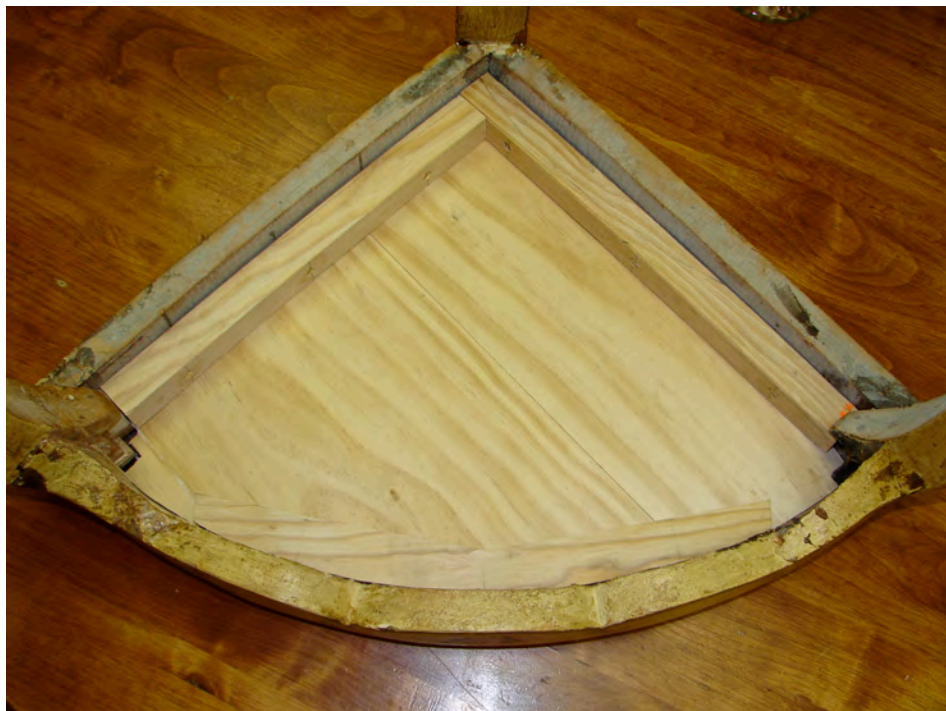
(THE FLOOR OF THE TABLE WAS DISINTEGRATING; WE SAVED THE TOP  
BOARDS AND SUPPORTED THEM FROM UNDERNEATH..)
