VICTORIAN BEADED ANGEL

## TREATMENT OF A BEADED VICTORIAN ANGEL

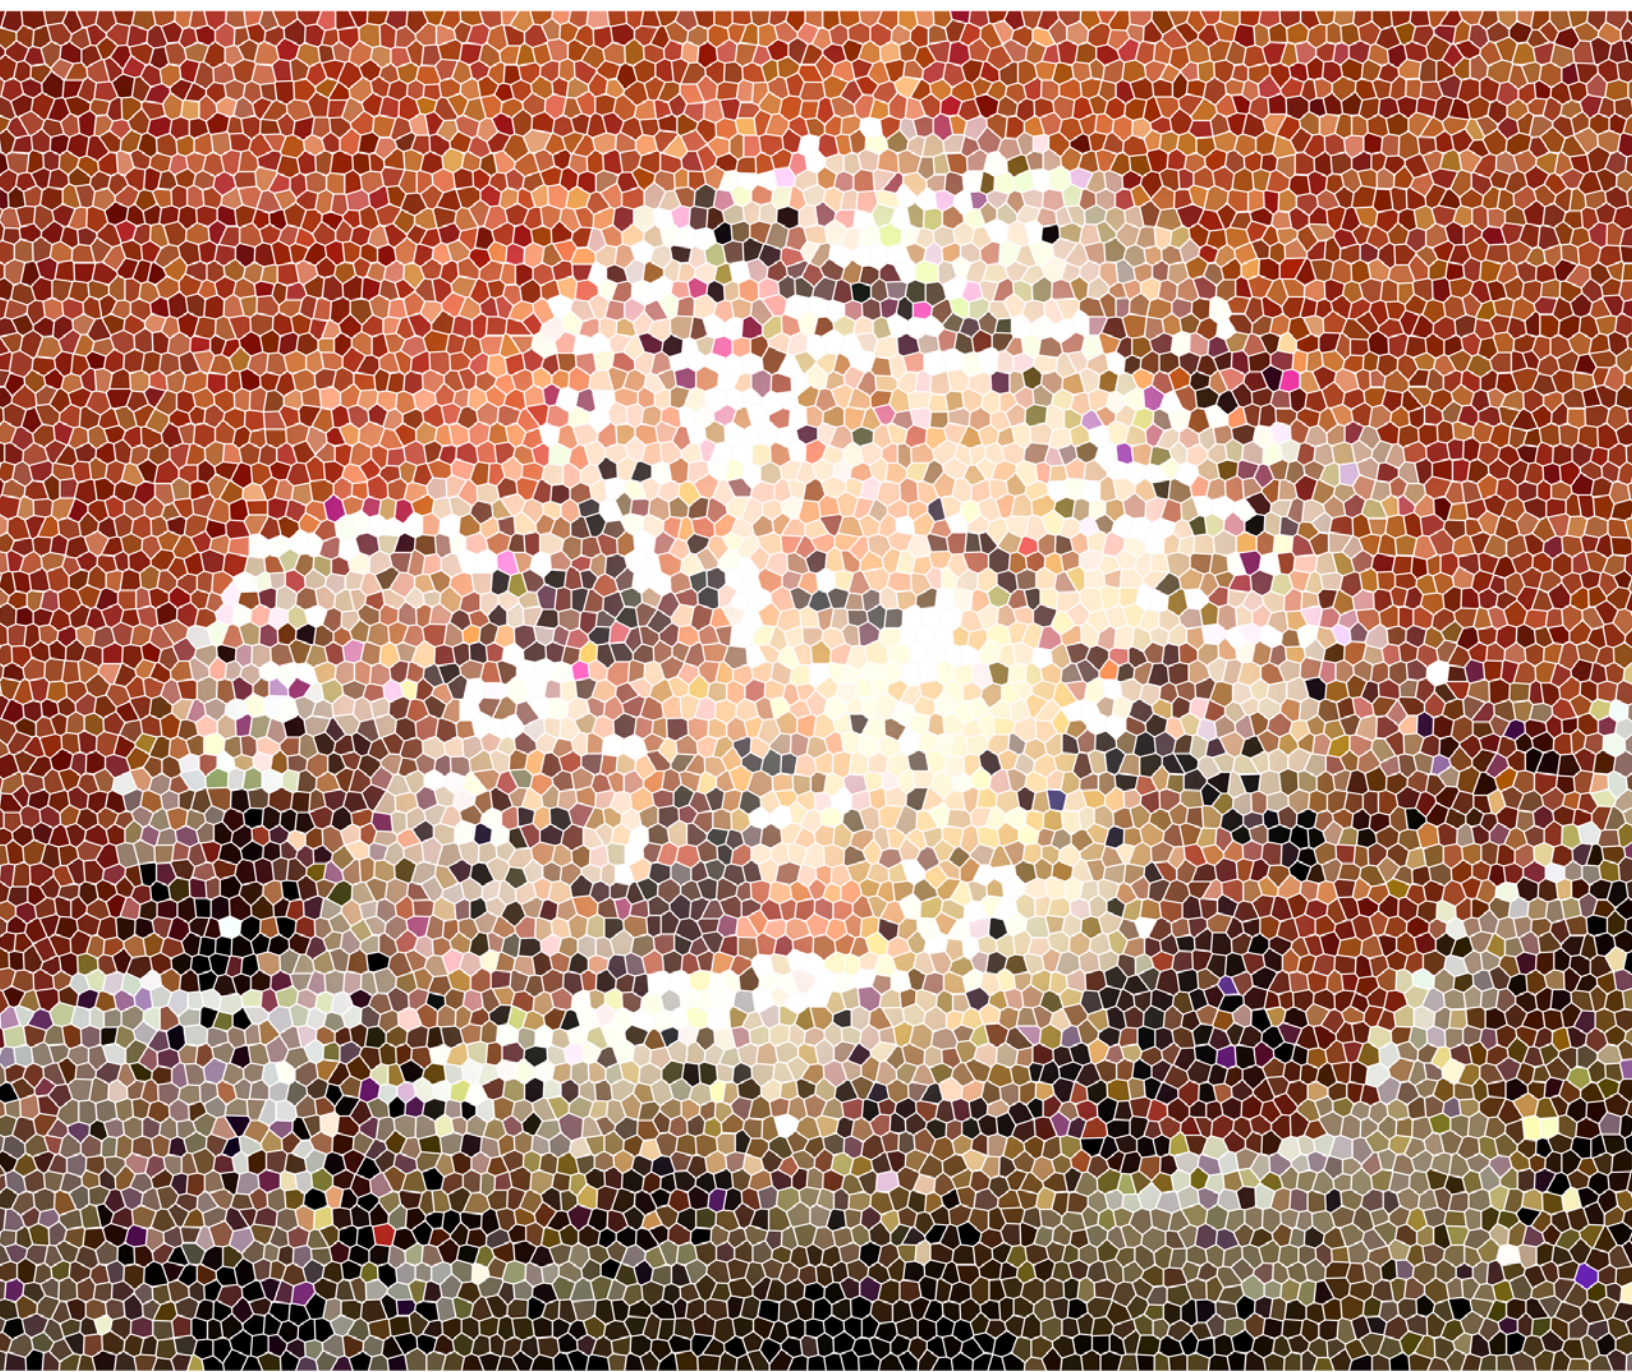
*Family heirloom, a Beaded Victorian Angel, before treatment. Beads missing in her hands, flowers, ribbons (three places), hair, wings, and her skirt (six). Yarn missing in several places, most notably in the lower left.*

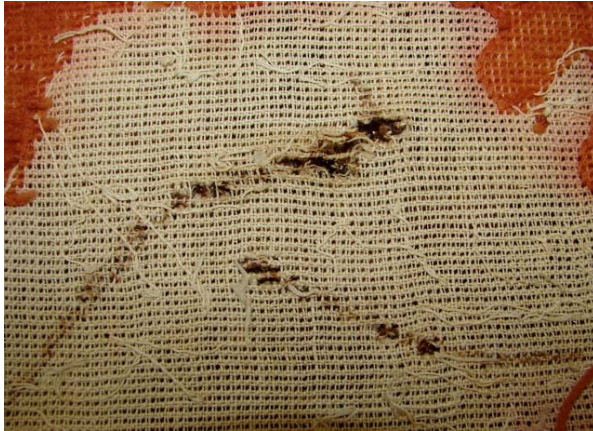
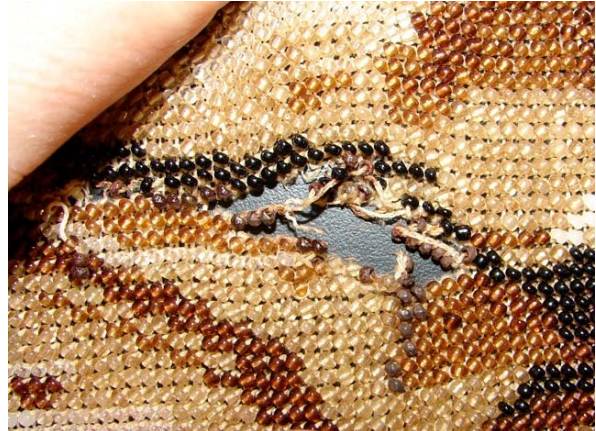
Top right and middle right, a beaded area with a 1 1/2-inch tear shown open and closed.

Bottom right, a second adjacent area to the tear, with 3 tears of 1/4-inch to 1/2-inch.

Top, reverse of the area shown right top and middle.

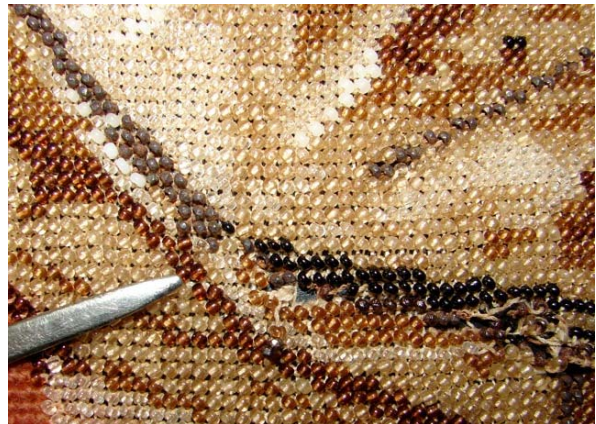
- I. The assessment in the MPF Conservation (hereafter known as MPFC) studio showed surprising information about the areas of extreme disintegration, an example shown top left, of the reverse side of the beaded item, and right.

- I.I. All areas ripped or disintegrated are areas where metallic beads have encountered either water or chemicals and have made the grid brittle and discolored, and leading to the disintegration.

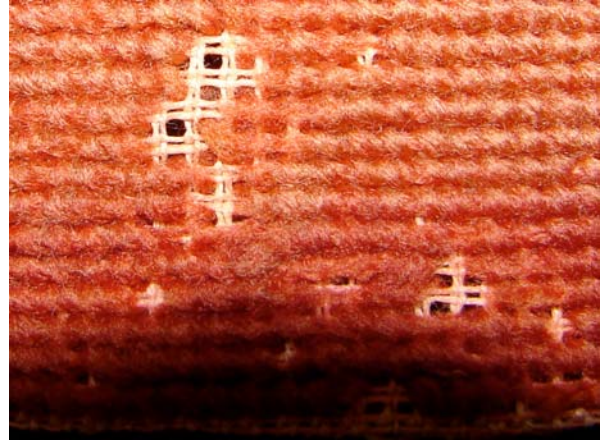
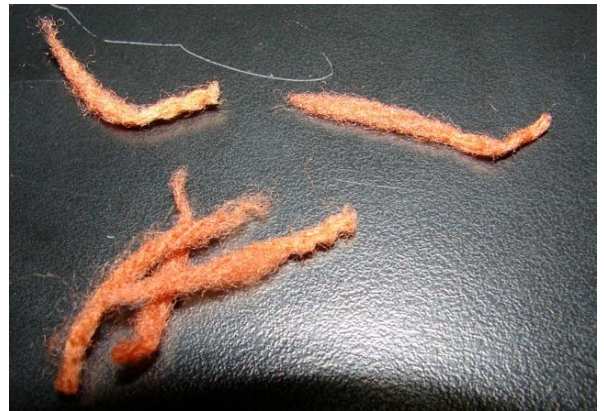
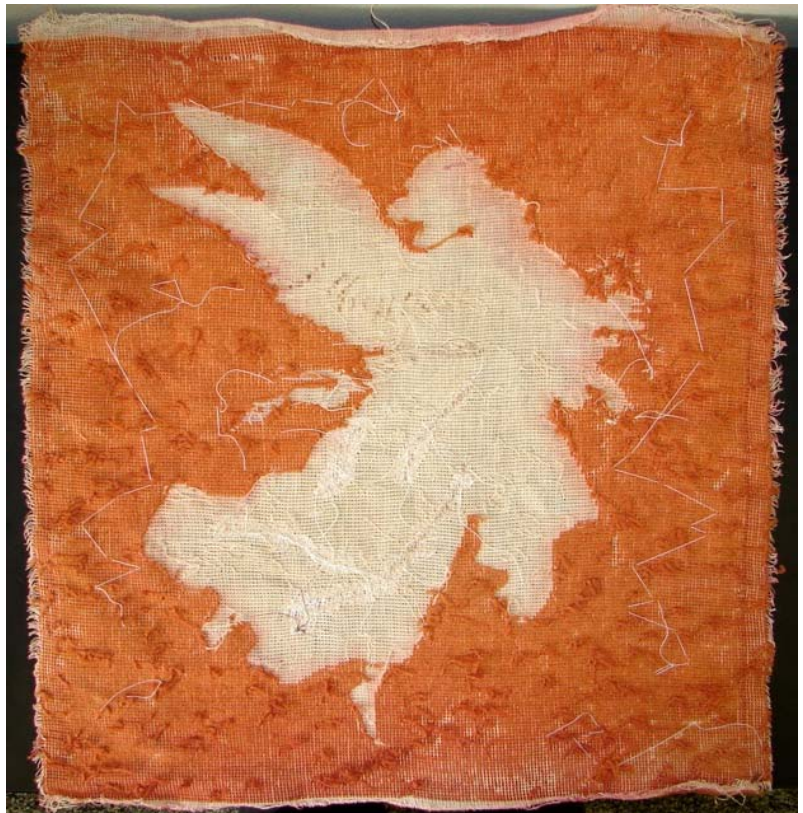
18. Missing yarn, especially in the lower right border, shown next page top right. was problematic, and outside our scope of work.

19. However, MPFC was able to “steal”  $\frac{3}{4}$ -inch to 1-inch tails of yarn to fill in several of the open areas of grid, shown center right.
20. This was used to fill in many of the small areas, as shown top right where one of the longest pieces was used to fill in two holes, and is seen as a lighter copper-colored yarn.

21. Unfortunately, we were unable to “steal” enough small pieces to completely fill in the open holes.
22. MPFC decided, since the goal was reparation that was non-invasive, to fill in the other holes with small clear sparkling beads, so as to look like stars, and then scattered some across the field, thereby covering the other holes in the missing field, and the positioning can be seen from the backside, shown bottom right.

23. Of course, this is easily reversible if the client chooses; it was not part of the original intention, but served to make a pleasing appearance to the angel.

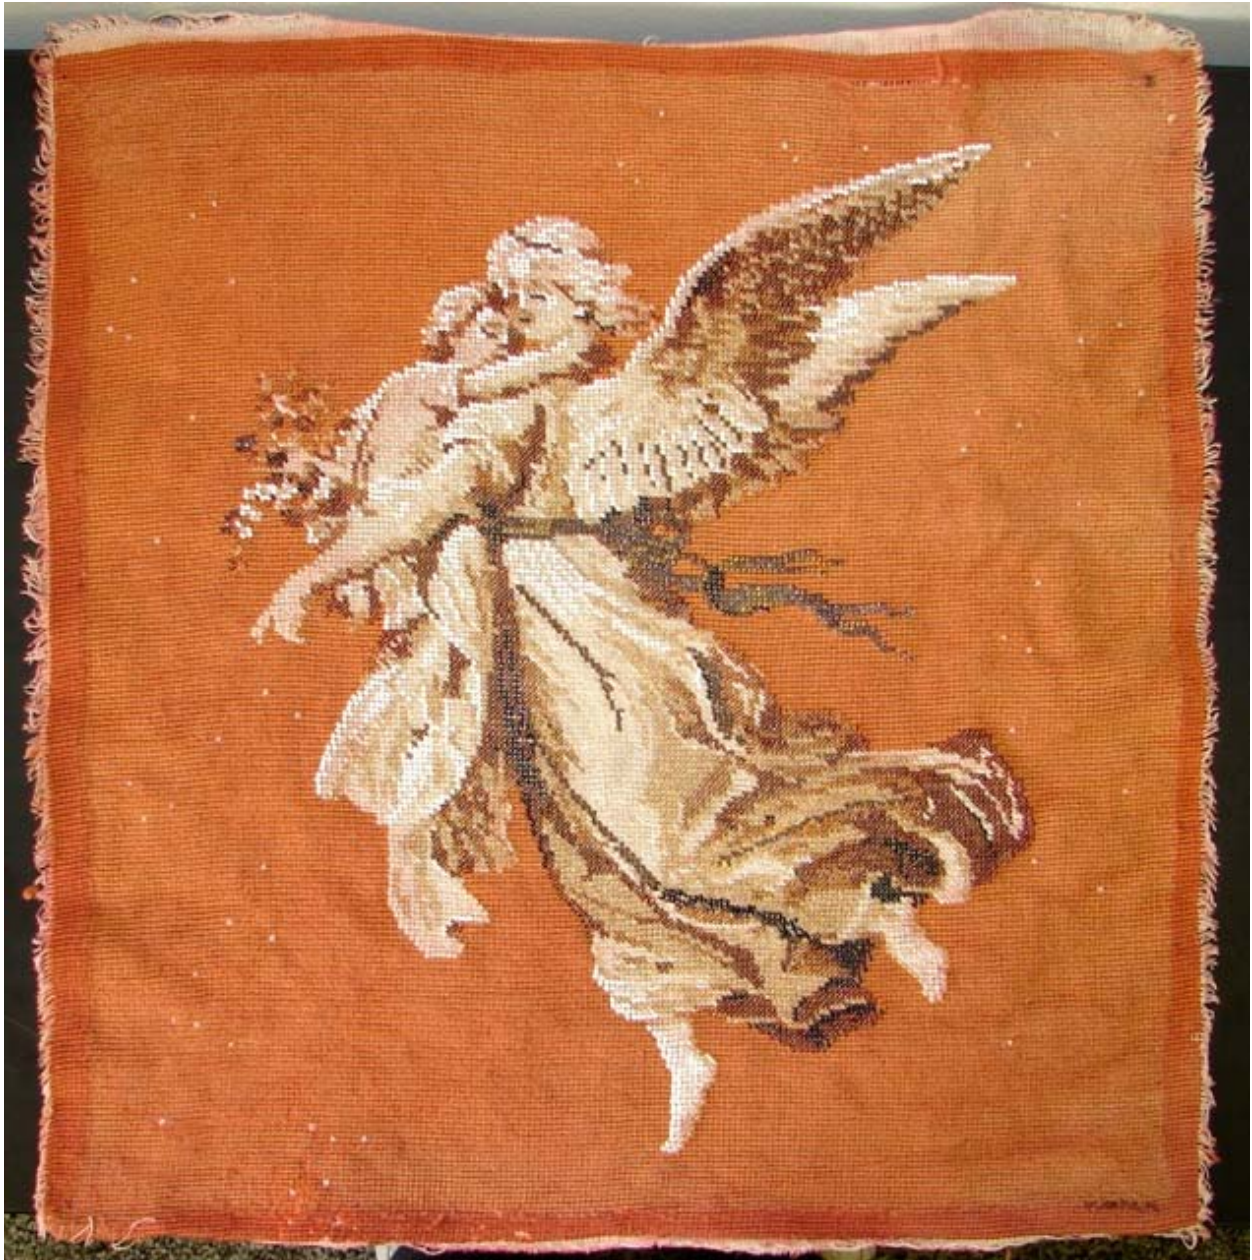
*Angel with baby, after treatment, above.*
